FORT DEVENS SITE INVESTIGATION FOR GROUPS 2, 7 & HISTORIC GAS STATIONS

REVISED FINAL SITE INVESTIGATION REPORT DATA ITEM A009

U.S. ARMY ENVIRONMENTAL CENTER ABERDEEN PROVING GROUND, MARYLAND

REVISED FINAL SITE INVESTIGATION REPORT GROUPS 2, 7 AND HISTORIC GAS STATIONS FORT DEVENS, MASSACHUSETTS

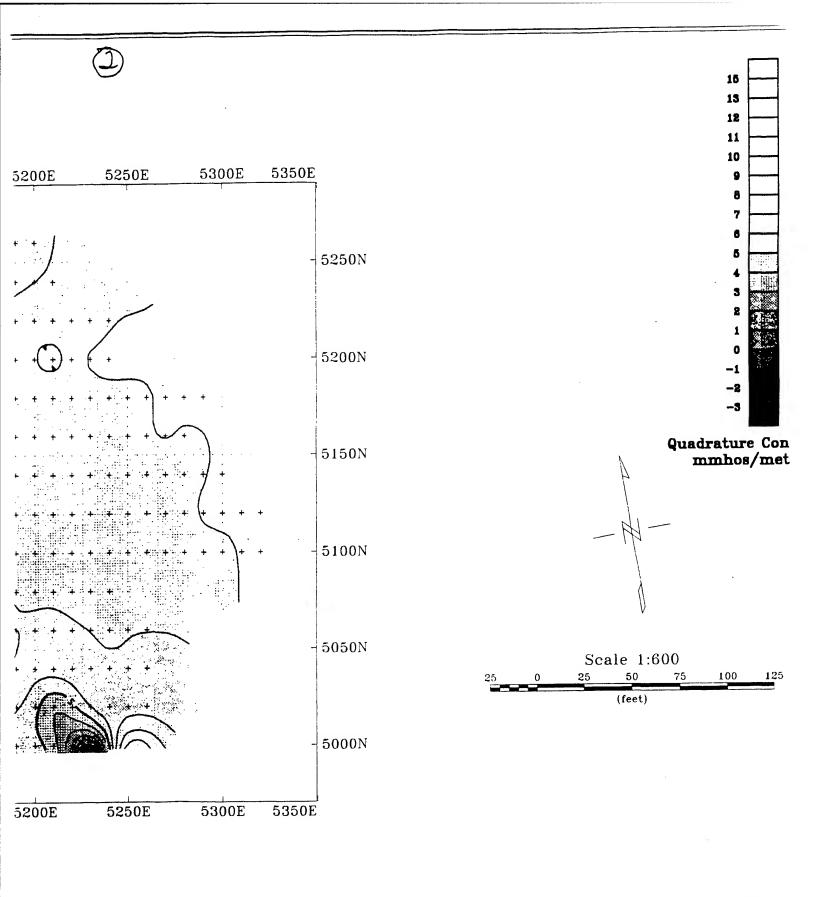
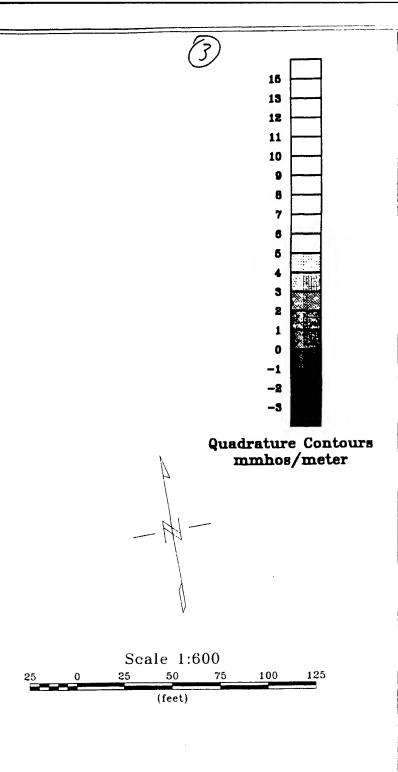
FIGURE 5.5-2
TERRAIN CONDUCTIVITY SURVEY RESULTS
SA 41 SITE INVESTIGATION REPORT
FORT DEVENS, MA

A surficial geophysical survey was conducted in the area directly north of SA 41, to determine if a source area of the chlorinated solvent contaminants, detected in the SI, could be found (see Figure 5.5-1). The geophysical survey consisted of a magnetometer survey and terrain conductivity survey. Based on the results of the surveys, no magnetic or ferrous metal anomalies were detected (Figures 5.5-2 and 5.5-3). These results of the surveys indicate that there did not appear to be source area for the detected groundwater contamination directly north of the waste material.
